MOHAWK RIVER BASIN
TOWN OF GERMAN FLATTS
HERKIMER COUNTY, NEW YORK

**ILION RESERVOIR
NO. 2 DAM
NY 00185**

PHASE I INSPECTION REPORT
NATIONAL DAM INSPECTION PROGRAM

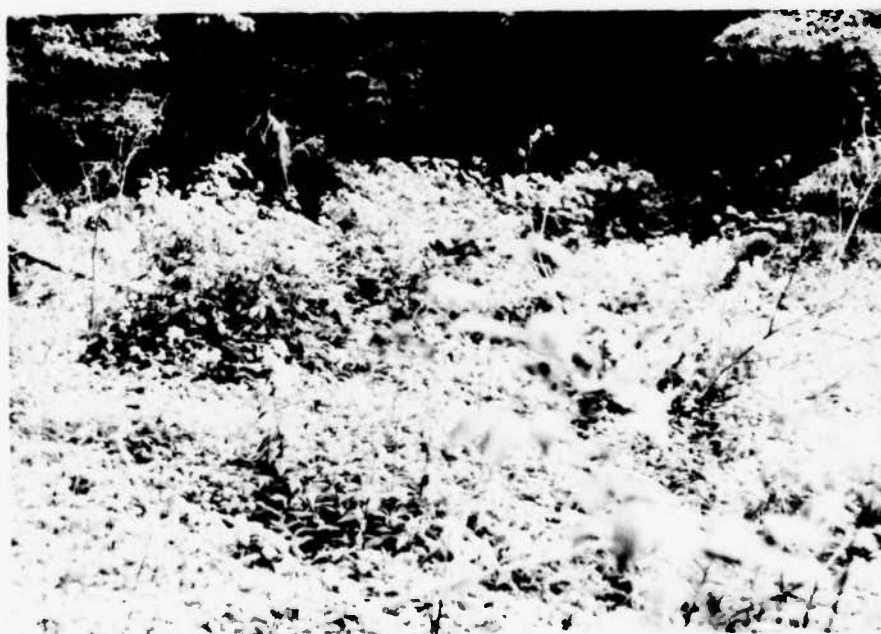
A-2B Cleared area to left of gate house at downstream toe of dam
6/4/81

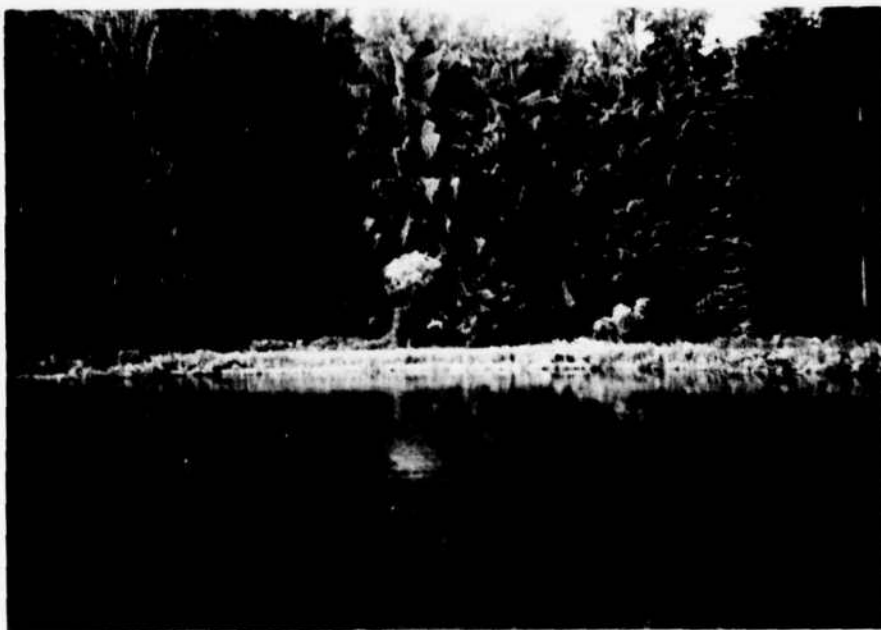
The auxiliary spillway consists of a concrete structure with a 4.5-foot-long ogee weir crest that discharges into a 15-foot-long section of 18-inch-diameter corrugated metal pipe (see Photos A-6B and A-7A). The weir structure concrete is weathered and stained. The 18-inch pipe from it is laid level and in good condition.

A-6B End of reservoir opposite dam. Note auxiliary spillway structure at center - 6/4/81
